NBS BUILDING SCIENCE SERIES 77

# Acoustical and Thermal Performance of Exterior Residential Walls, Doors and Windows

*1105*  
Hale J. Sabine and Myron B. Lacher

Daniel R. Flynn and Thomas L. Quindry

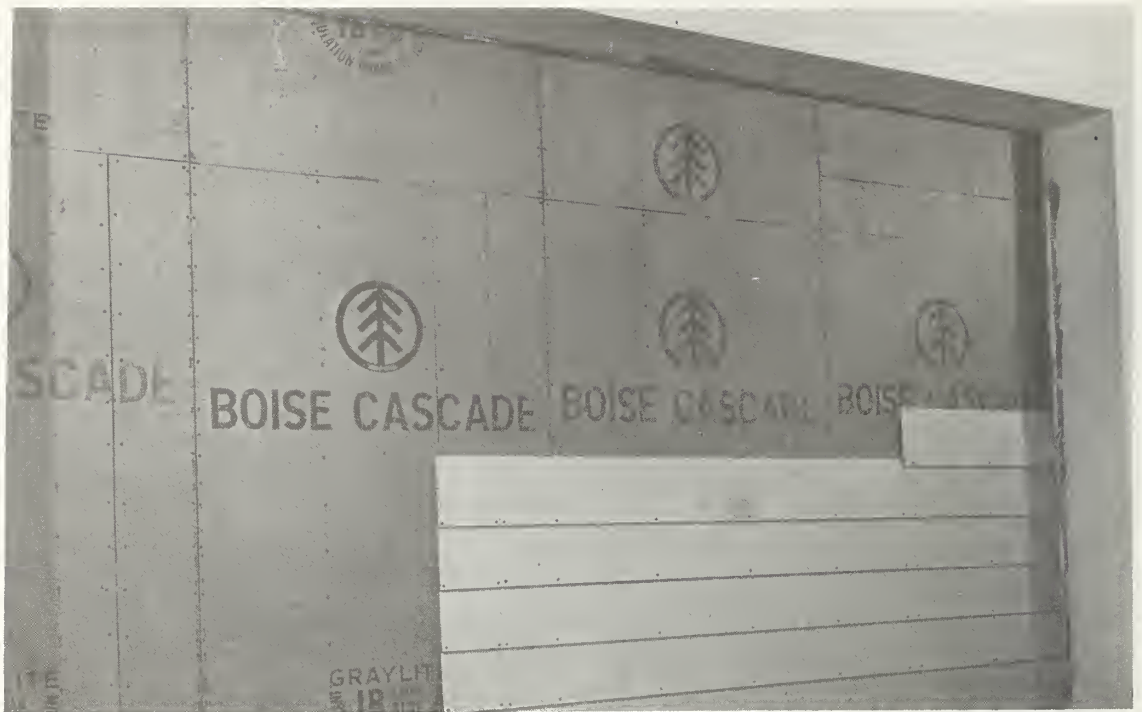
Figure 1. Application of wood siding to frame wall installed in sound transmission facility.

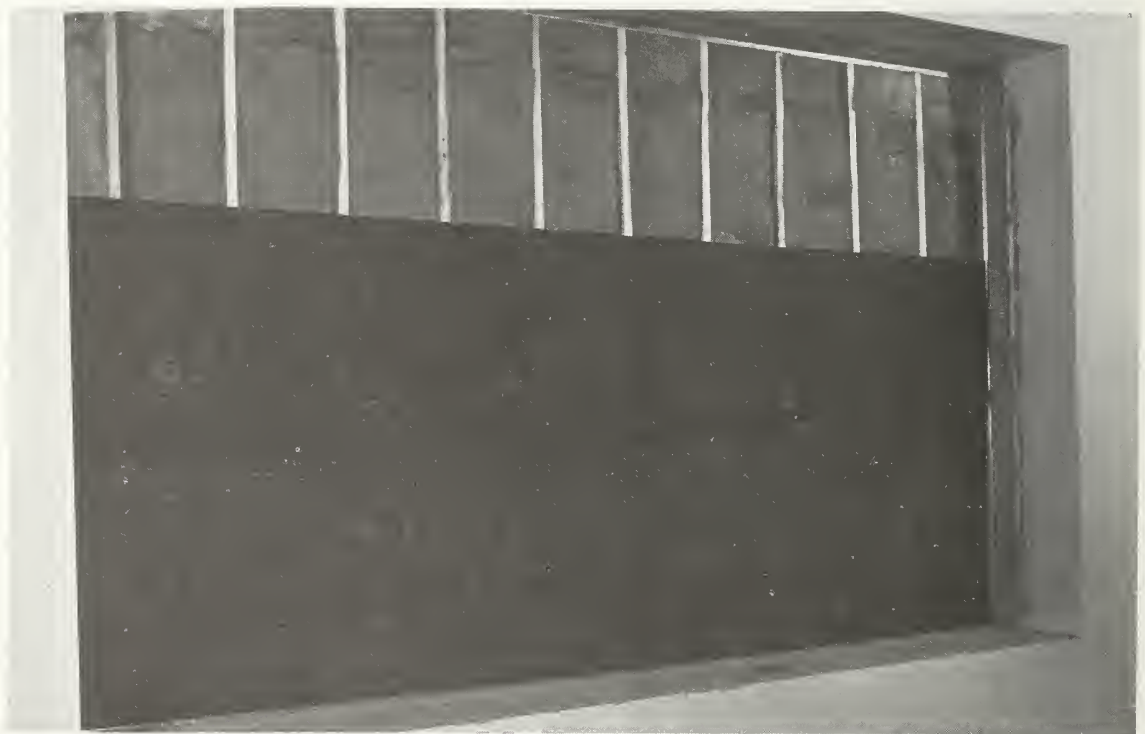
Figure 2. Application of building felt and wire mesh prior to stucco application.

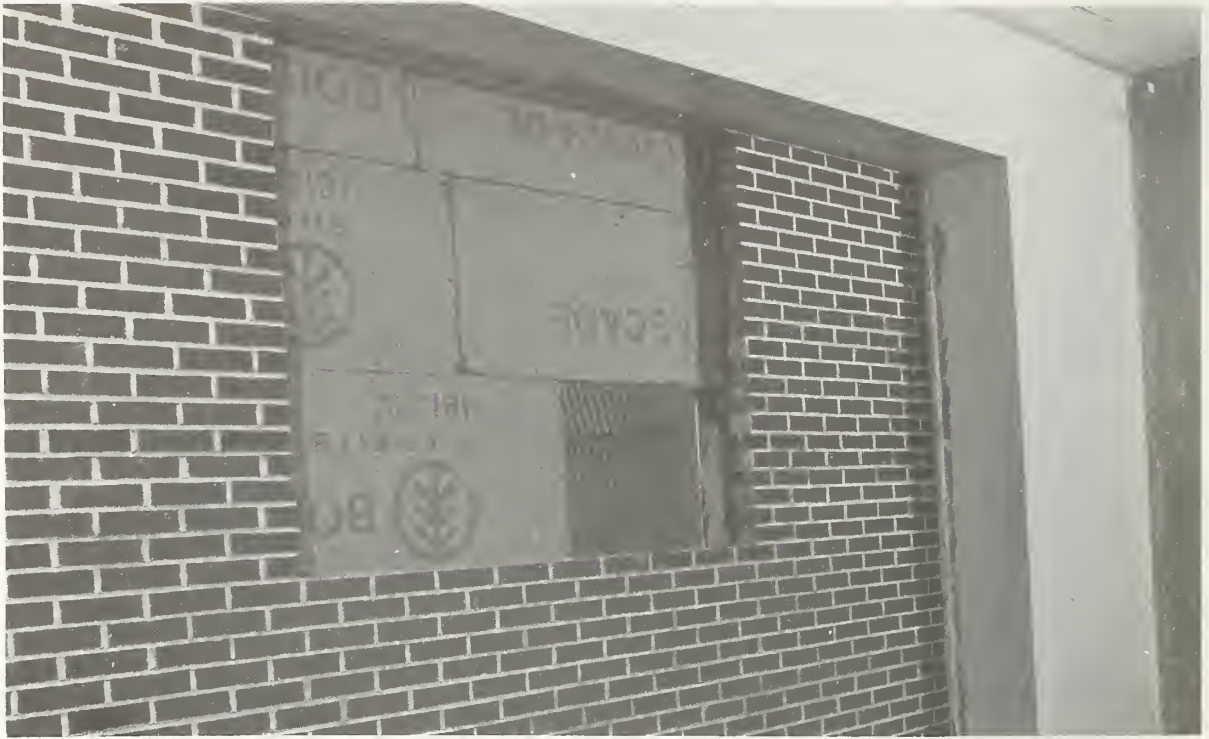
Figure 3. Brick veneer wall with opening cut for picture window.

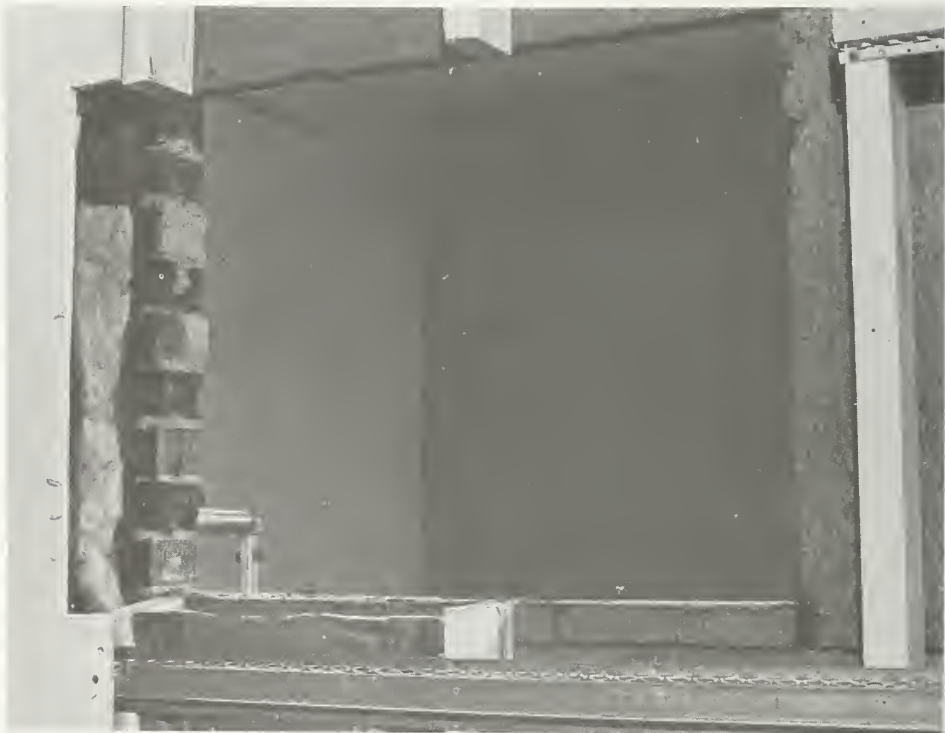
Figure 4. Detail of brick veneer wall construction with resilient channel and cavity insulation.

The resilient drywall channel, when used, was one of three makes of product which had been previously tested and found essentially equivalent for sound isolation. The channel was nailed horizontally to the studs on 2 ft spacing, and the gypsum board was screwed into the channels (see Figure 4). At the bottom, the gypsum board was screwed into the studs through a gypsum board base strip in accordance with standard field practice; this, however, reduces the potential sound isolating value of the resilient channel appreciably, as shown by earlier tests.

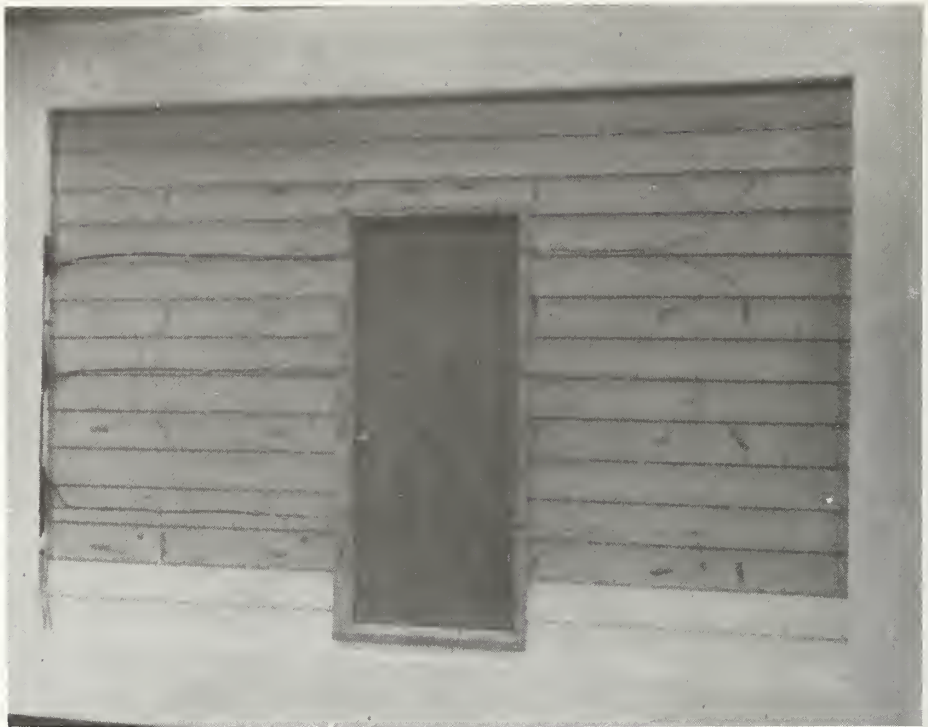
Figure 5. Solid core flush wood door mounted in wood siding wall for thermal test.

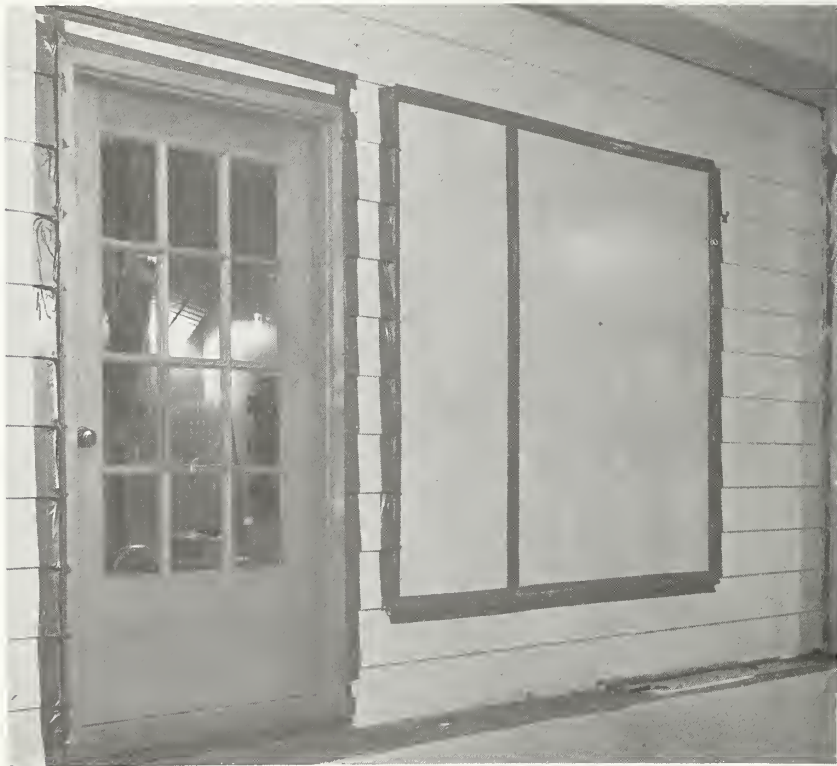
Figure 6. Wood french door mounted in wood siding wall for sound transmission and air infiltration test. Auxiliary construction on opposite side eliminates significant flanking sound transmission.

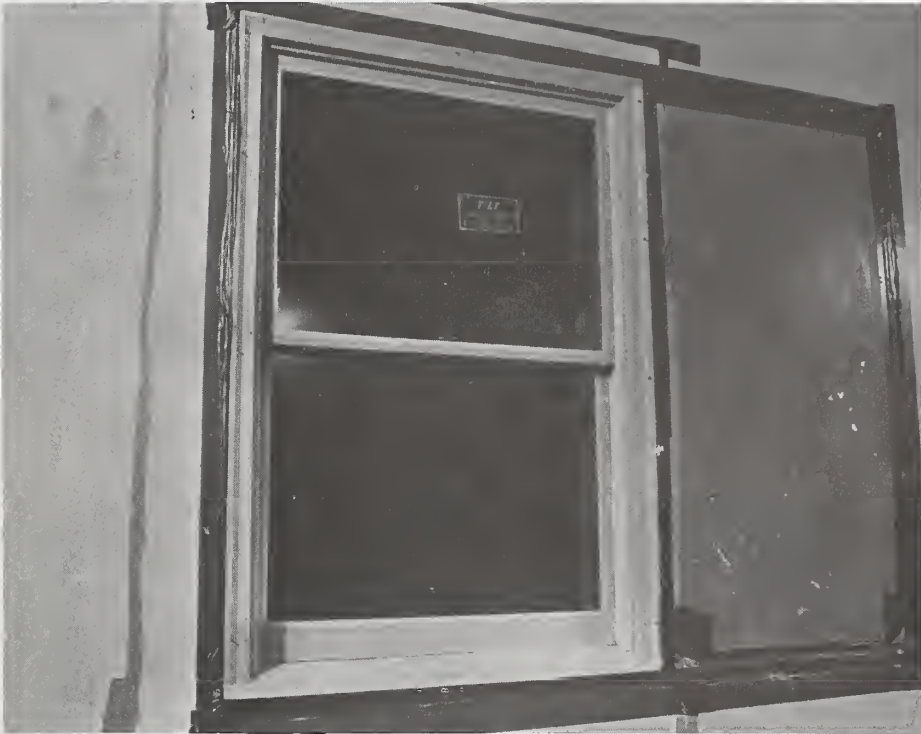
Figure 7. Wood double-hung window installed in filler wall.

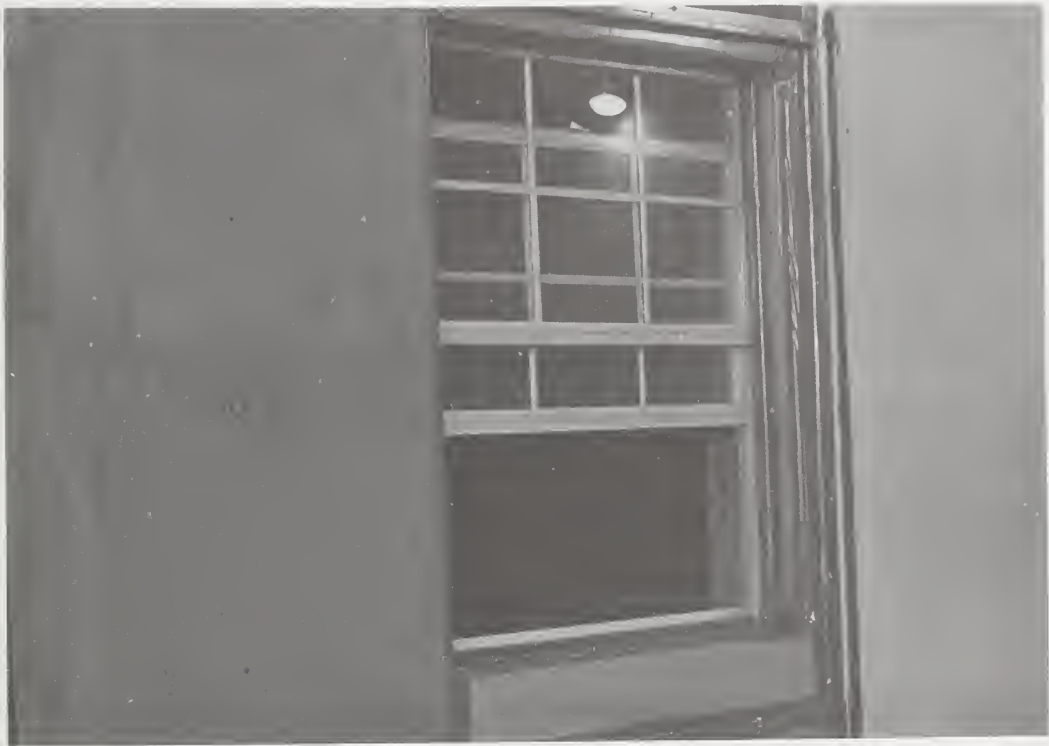
Figure 8. Aluminum single hung window.

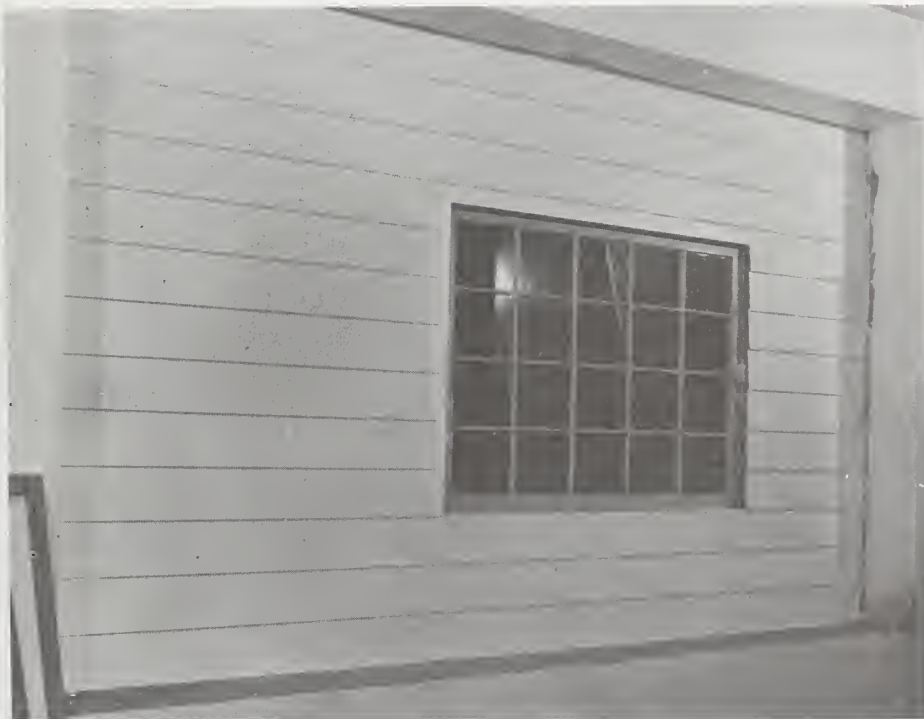
Figure 9. 6 x 5 ft picture window installed in wood siding wall.

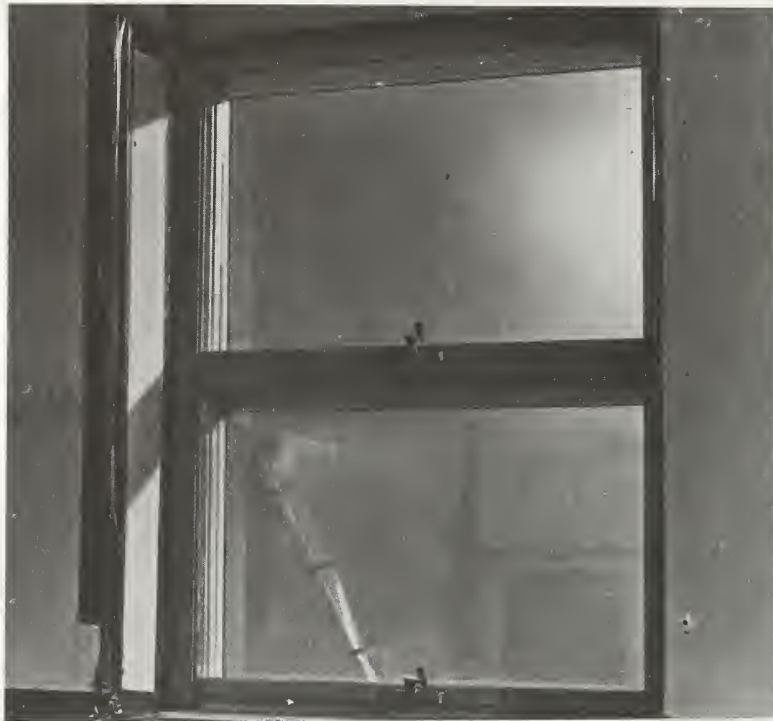
Figure 10. Auxiliary construction erected on interior side of wood siding wall for sound transmission testing of window.

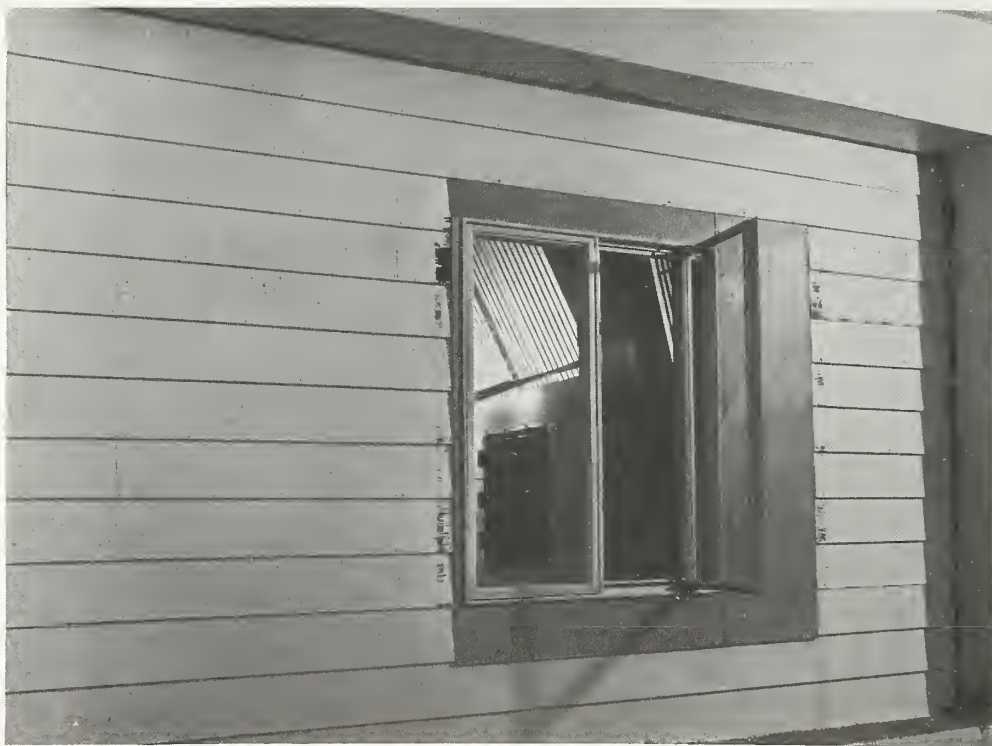
Figure 11. Plastic coated wood operable casement window.

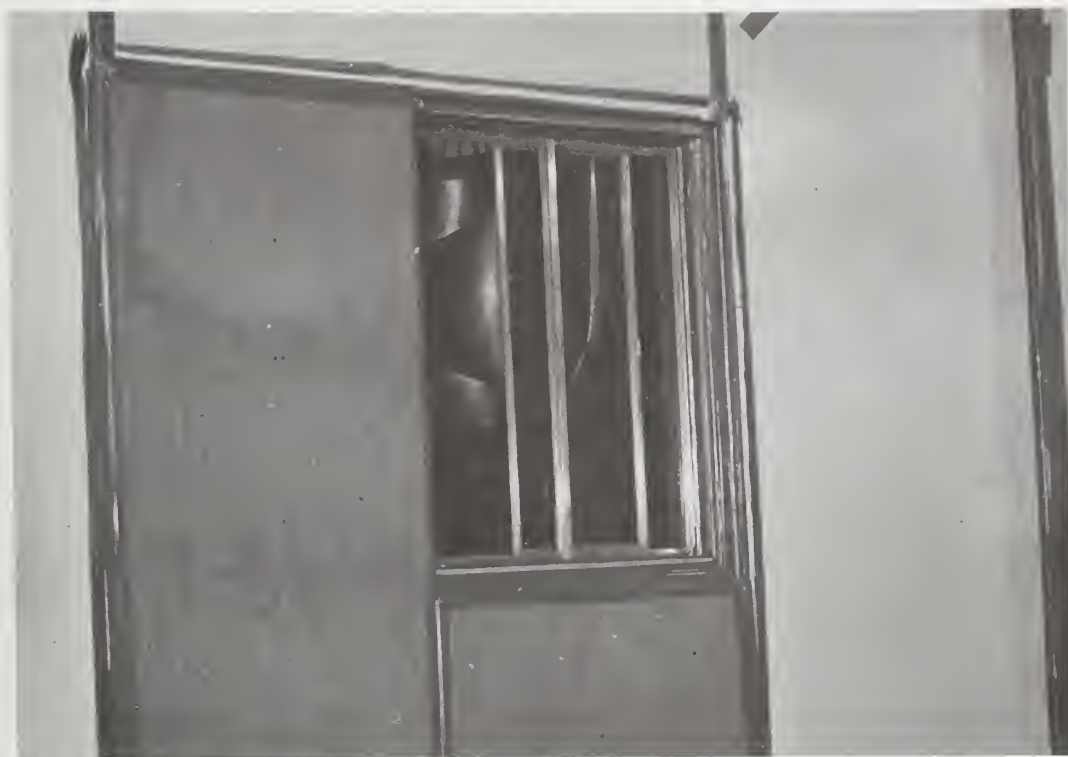
Figure 12. Aluminum Sliding window.

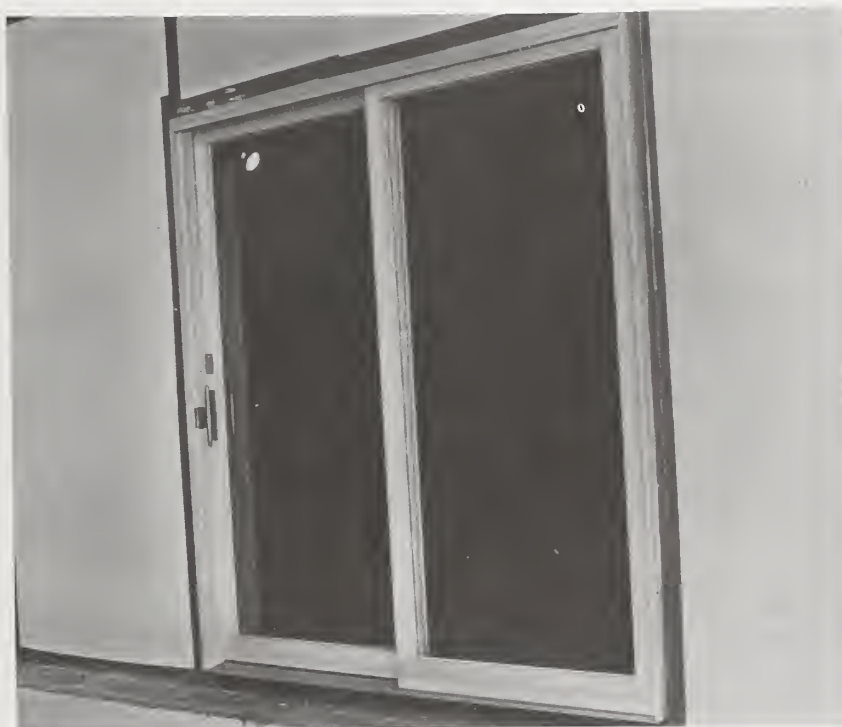
Figure 13. Plastic coated wood sliding glass door.

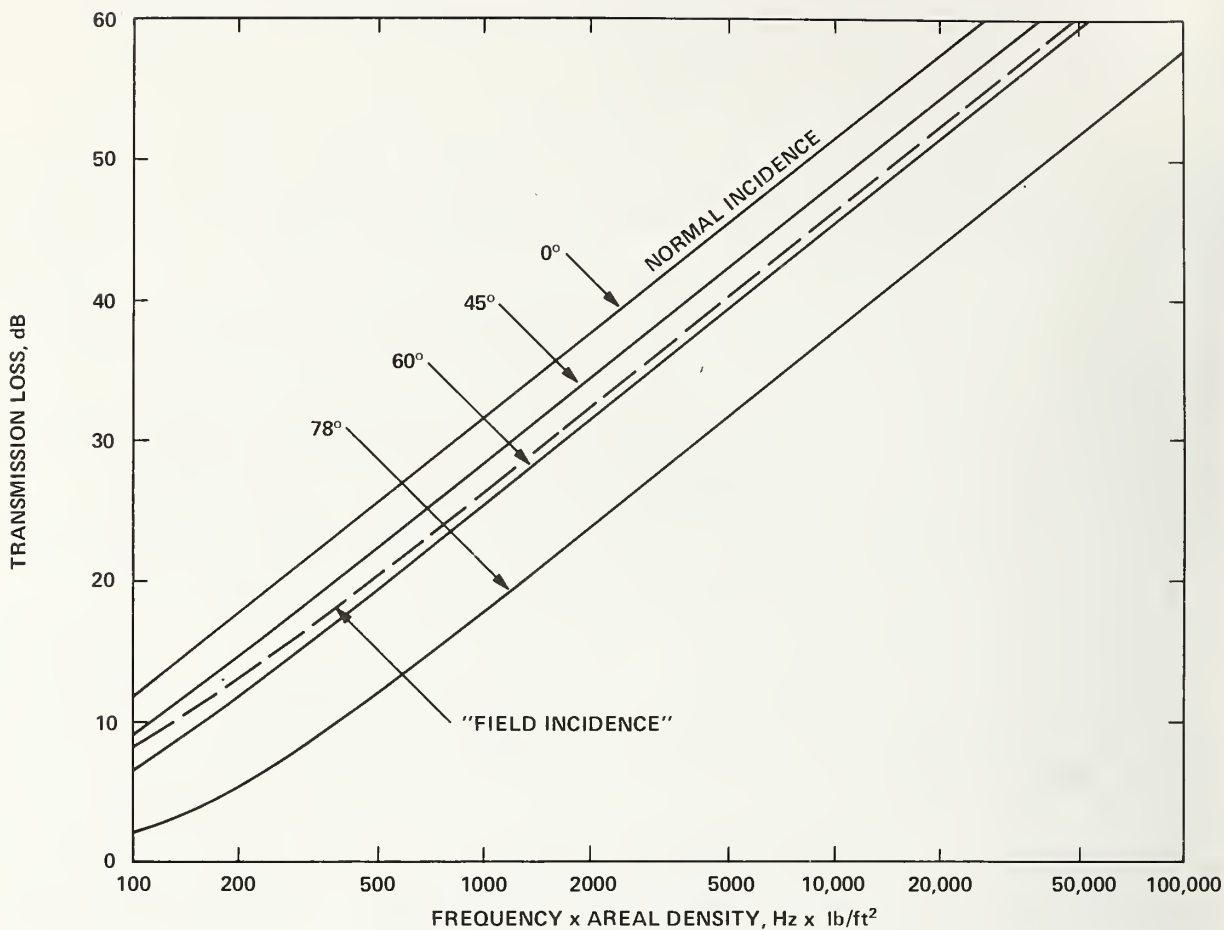
Figure 14. Limp-wall mass law transmission loss. The solid curves correspond to a plane wave arriving at a discrete angle of incidence. The dashed curve corresponds to "field-incidence mass law", a sum over all angles of incidence up to 78°.

<sup>6/</sup> The integration is only taken up to  $78^\circ$  rather than  $90^\circ$  so as to obtain better agreement with experimental data. The finite size of the partition, the effect of the test facility, and possible damping effects in the wall for near-grazing incidence are probably responsible for the observed deviations between experiment and the simple mass-law theory [12, 20-21].

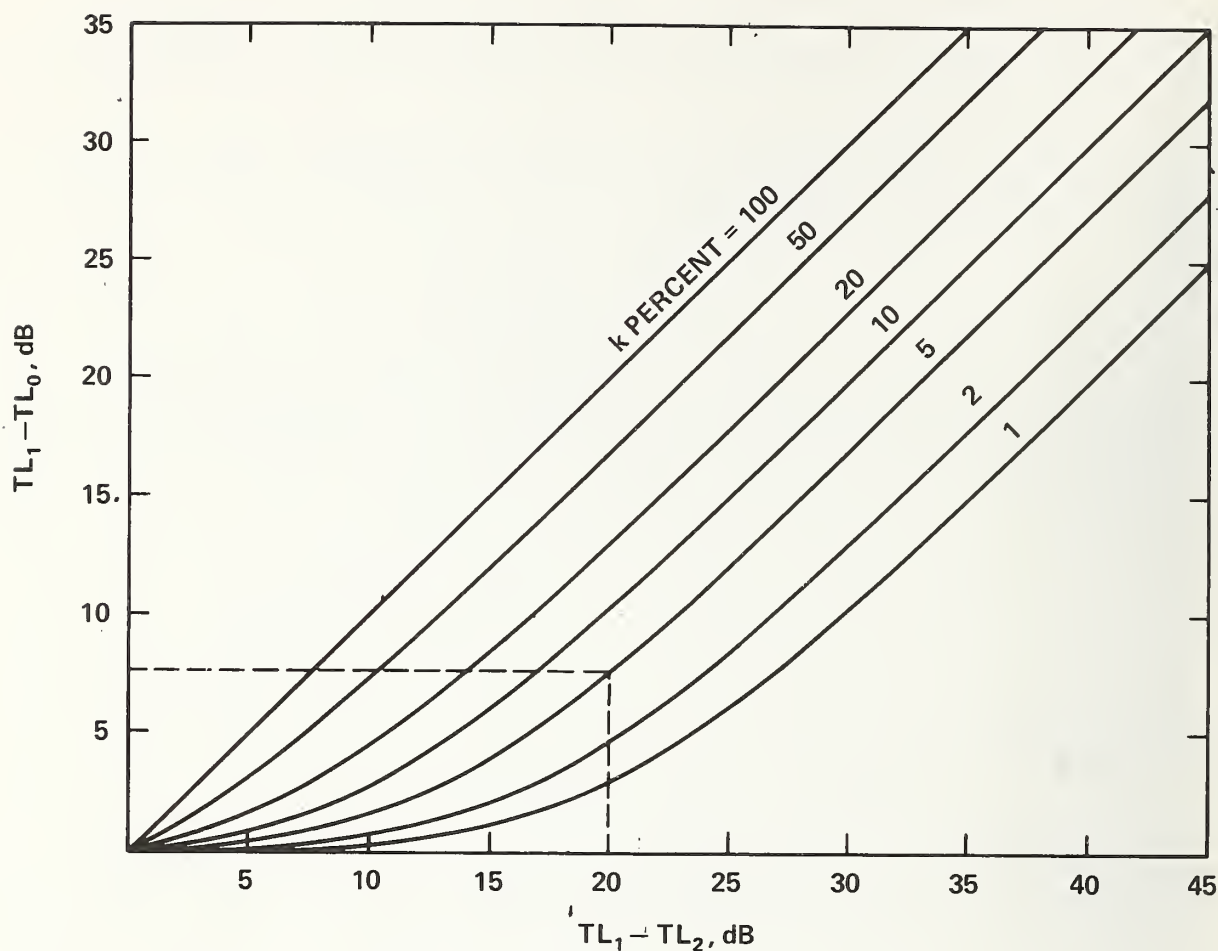
Figure 15. Chart for determining the overall sound transmission loss,  $TL_0$ , of a wall with a penetration (e.g., door or window) having a transmission loss,  $TL_2$ , less than the transmission loss,  $TL_1$ , of the basic wall construction. The penetration occupies "k percent" of the total wall area. The transmission loss of the combination is shown in relation to that of the wall as  $TL_1 - TL_0$ . Example: A window with  $TL_2 = 30$  dB occupies 5 percent of the area of a wall with  $TL_1 = 50$  dB. Then,

A chart derived from equation (4) for estimating the overall transmission loss of any combination of a wall and a single penetration such as a door or window, knowing the area and transmission loss of each component, is shown in Figure 15. The linear portions of the curves in Figure 15 correspond to situations where nearly all of the sound energy comes through the portion of the wall having the lower transmission loss so that  $TL \approx TL_o + 10 \log (100/k)$ , where  $k$  is the percent of the total wall area occupied by the door, window, crack or other path of low sound transmission loss. Consideration of eq. (2) and Figure 15 reveals that even a small area having a low transmission loss can greatly reduce the overall transmission loss below that of the basic wall structure. Since cracks may have a transmission loss that is near zero, "leaky" doors, windows, and louvers can vitiate an otherwise good construction. The effect of cracks is discussed in some detail in Sections 3.6 and 6.1.

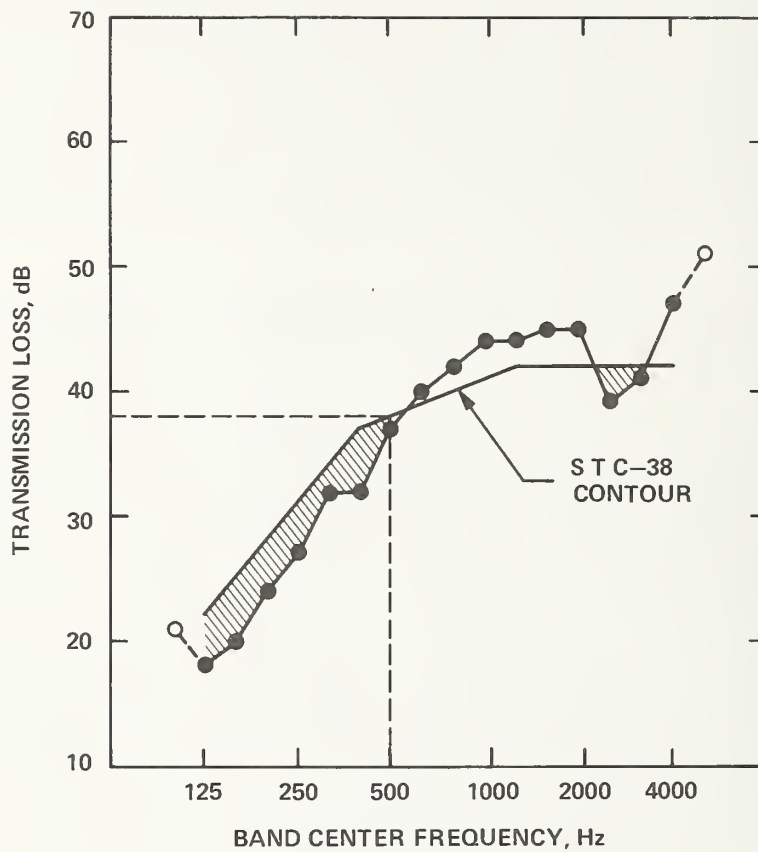
Figure 16. An example of a Sound Transmission Class contour fitted to a sound transmission loss curve. The fitting procedure is described in the text.

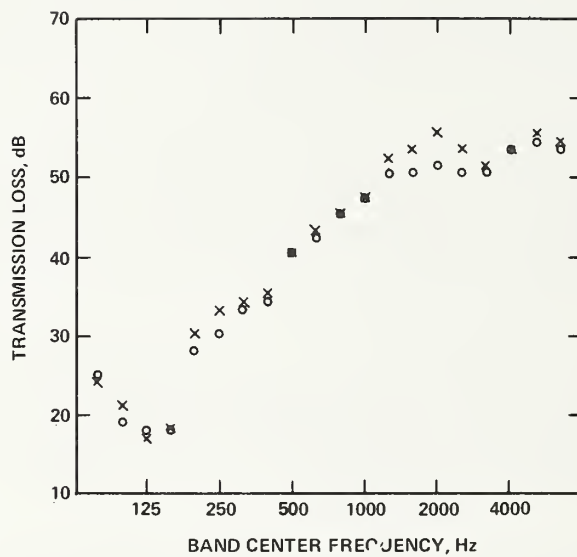
Figure 17. Sound transmission loss vs frequency data for wood-siding, wood-stud exterior wall with cavity insulation. Repeat tests (W-54-71 and W-3-72) on same nominal construction using different lots of materials.

The repeatability of a test on two different installations of the same nominal construction in the Owens-Corning Fiberglas Sound Laboratory, using different lots of materials, is shown in Figure 17. The tests were made four months apart on a standard wood stud exterior wall with wood siding and insulating sheathing on the outside and gypsum board drywall on the inside. The maximum difference between the curves at any frequency from 80 to 6300 Hz is 4 dB, and the difference between the averages for the two curves is 1.2 dB.

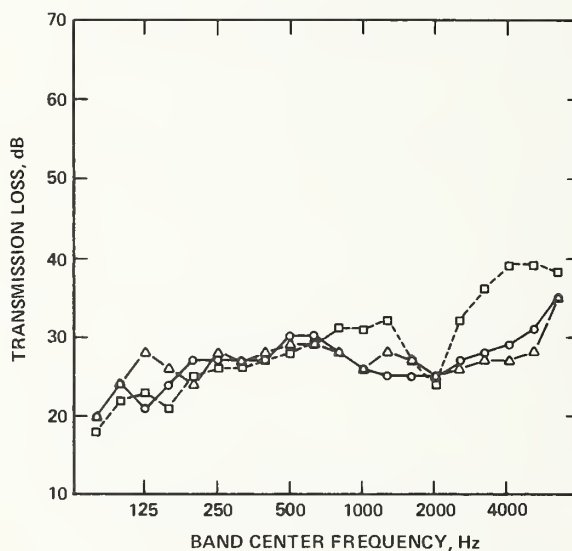
Figure 25. Comparison of effect of three types of weather stripping on sound transmission loss vs frequency data for doors.

Symbol	Test No.	Specimen	STC
○	W-90-71	Spring brass on 3 sides of solid core wood door; plastic half-round threshold strip	27
△	W-42-72	Same except extruded plastic 3 sides	27
□	W-2-72	Magnetic strip on 3 sides of steel door, plastic fingers on bottom	28

Figure 25 shows a comparison of three weather strips. Two of these were spring brass and extruded plastic, the latter being substituted for the former in the same door frame and with the same solid core wood door. The threshold was a half-round plastic strip. By referring to the sealed door in Figure 22, it is seen that both weather strips reduced the TL by about the same amount; namely 3 to 8 dB at the higher frequencies and from 30 to 27 STC.

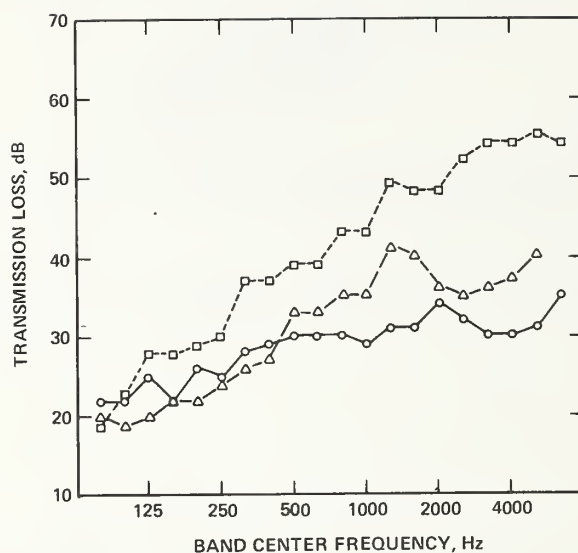
Figure 26. Comparison showing the effect of adding a storm door on the sound transmission loss vs frequency of a solid core wood door.

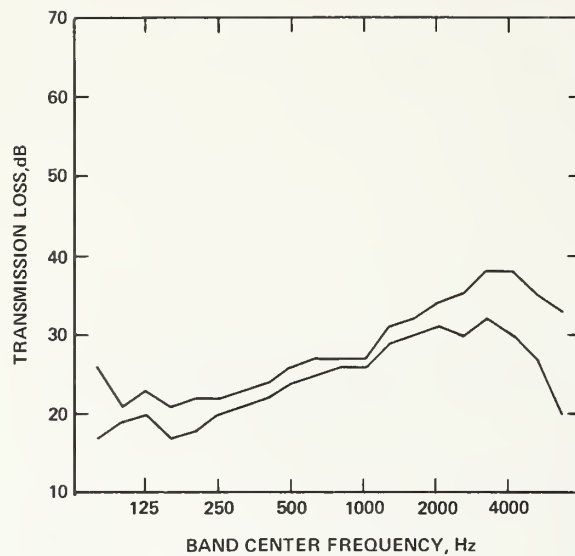
Figure 28. Envelope of sound transmission loss vs frequency data for five sealed windows with single-strength glazing (Tests W-8-71, W-33-71, W-41-71, W-76-71, and W-26-72). Windows include: wood and aluminum sash, single and divided lights, sash areas from 6 to 30 sq ft. The corresponding Sound Transmission Class range is STC 28-29.

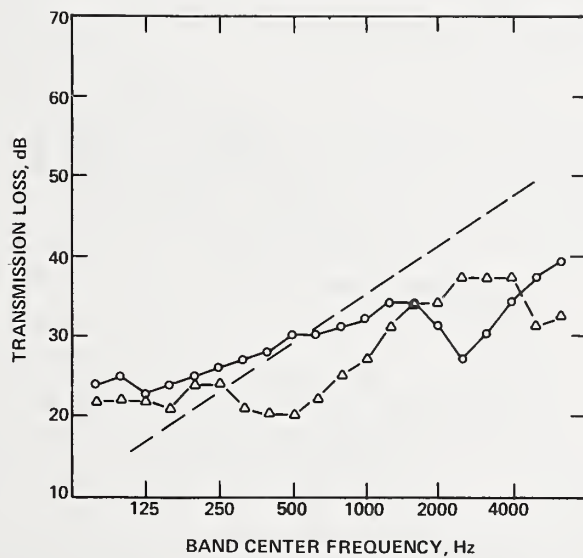
Figure 30. Comparison of sound transmission loss vs frequency data for insulating glass <sup>2</sup> with data for single glazing of the same surface density (nominally 2.6 lb/ft<sup>2</sup>). The dashed curve represents field incidence mass law (see Figure 14 and accompanying text).

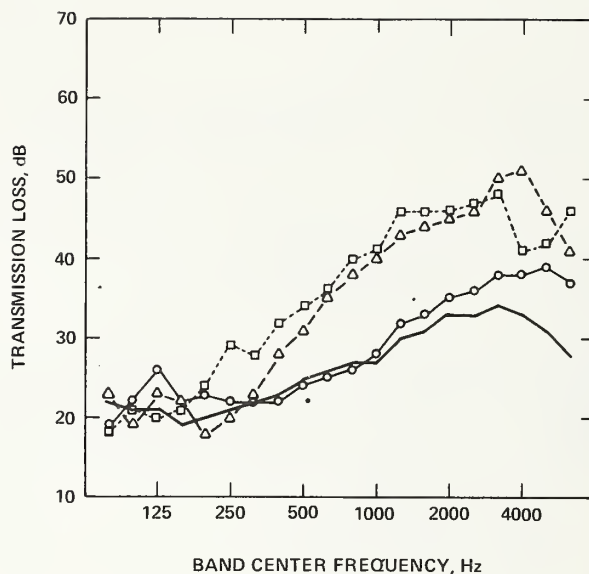
Figure 31. Comparison of sound transmission loss vs frequency data for sealed single-strength windows with storm sash (at various spacings from primary glazing) with data for sealed windows, glazed single-strength with storm sash. In the following table the spacing is the average between panes for upper and lower sash.

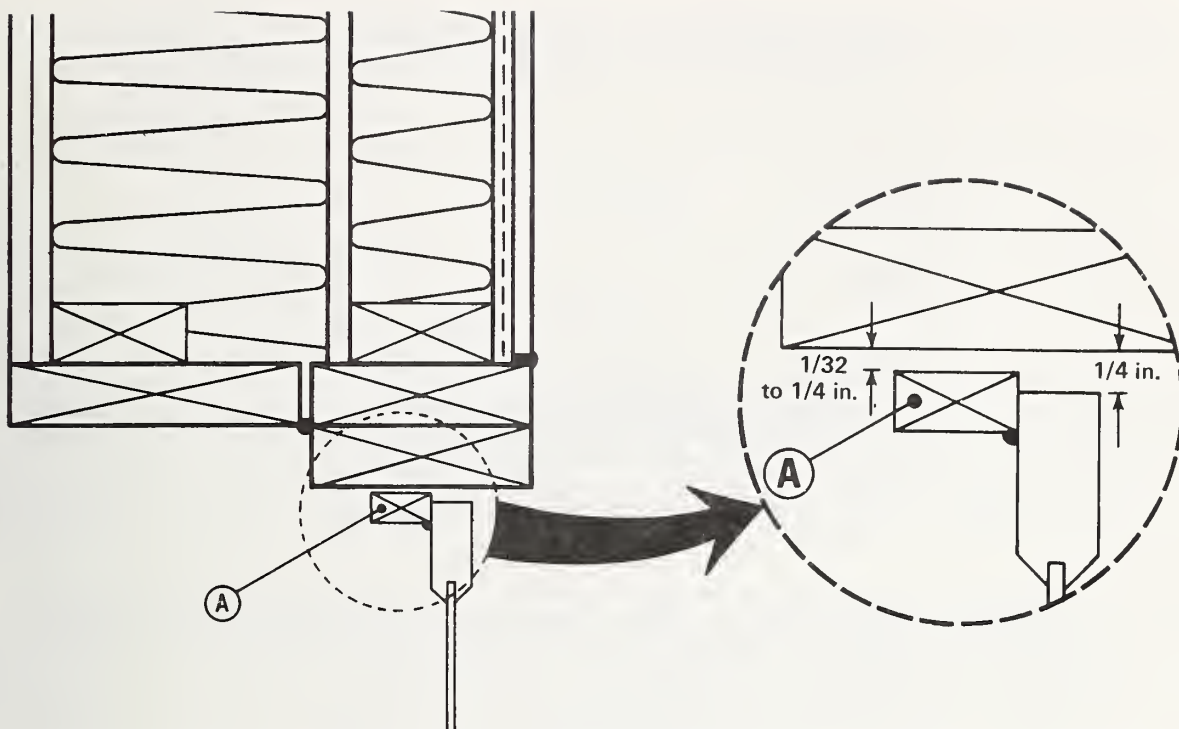
Figure 32. Detail of framing in filler wall to receive picture window sashes. Strip A was shimmed out to provide perimeter cracks ranging from 1/32 to 1/4 in.

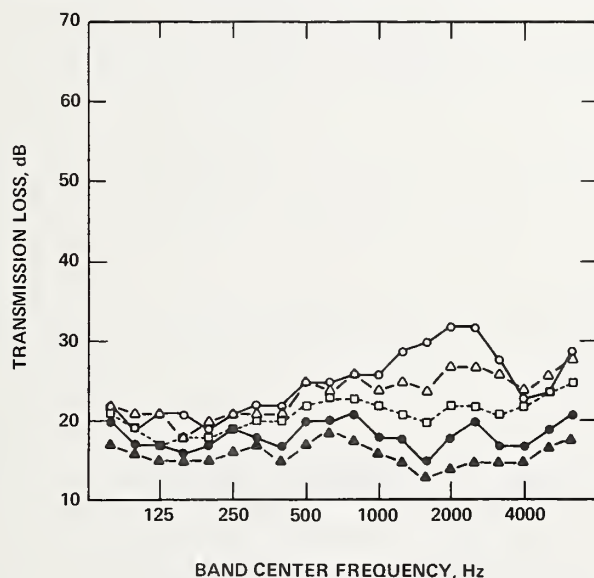
Figure 33. Sound transmission loss vs frequency data for 6 x 5 ft picture window, double-strength glazing, with perimeter cracks of controlled size.

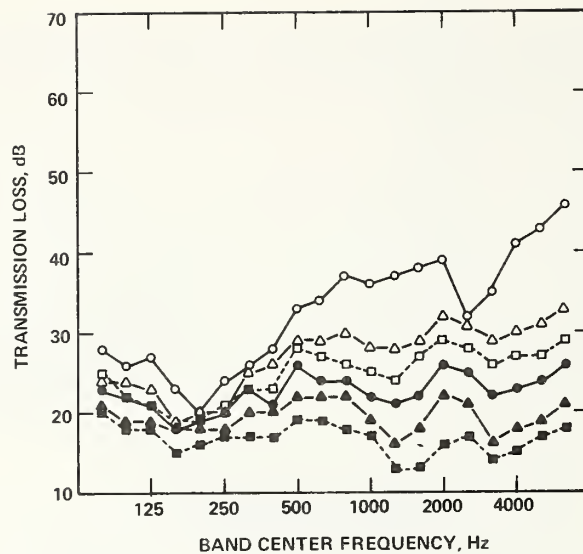
Figure 34. Sound transmission loss vs frequency data for 6 x 5 ft picture window, glazed with 1 in. insulating glass, with perimeter cracks of controlled size.

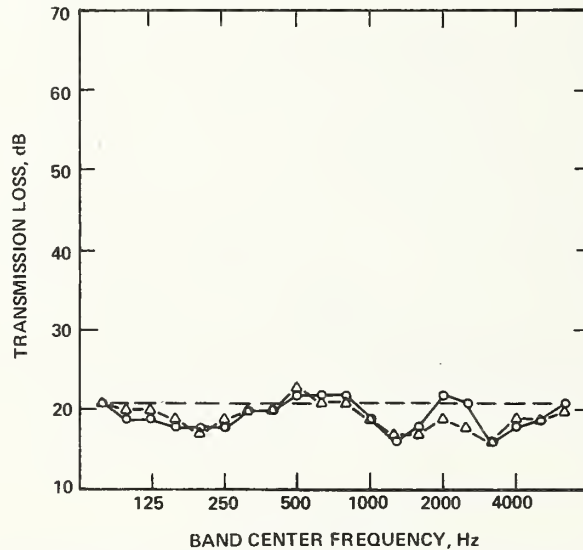
Figure 35. Comparison of effect of perimeter cracks of the same area, but different widths, on the sound transmission loss vs frequency for a 6 x 5 ft picture window, glazed with 1 in. insulating glass. The dashed horizontal line corresponds to the theoretical transmission loss, based on the ratio of crack area to window area, assuming the transmission loss of the crack is 0 dB.

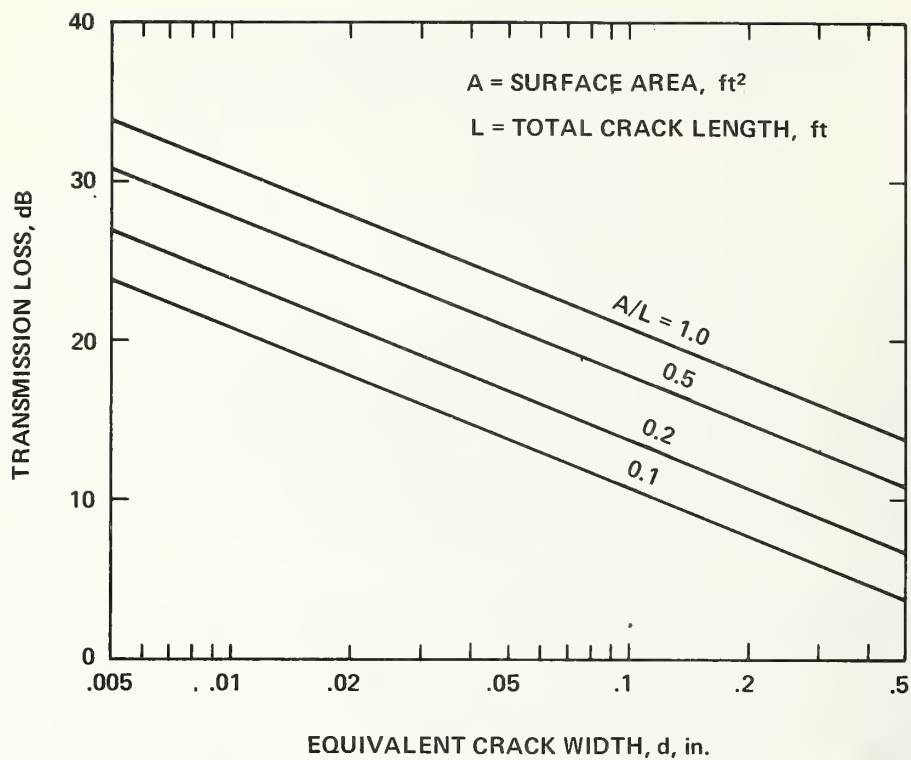
Figure 36. Theoretical sound transmission loss of surface with cracks, assuming the sound transmission loss of the sealed surface is at least 10 dB higher than that of the surface with cracks (see text).

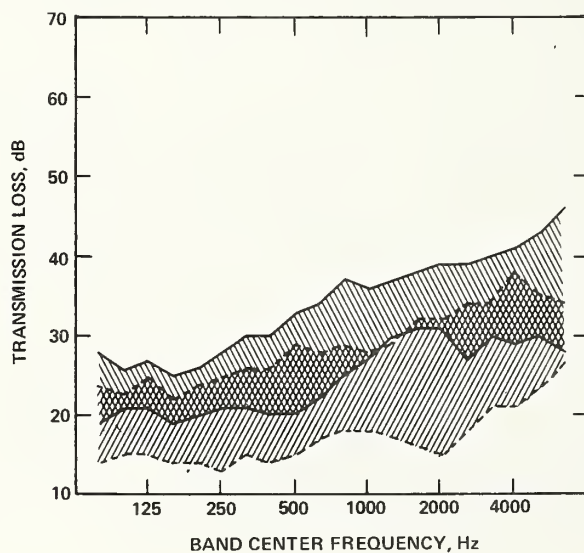
Figure 37. Comparison of the envelope (corresponding to STC 26-34) of sound transmission loss vs frequency data for all sealed windows with the envelope (STC 17-30) of data for all unsealed windows, locked and unlocked.

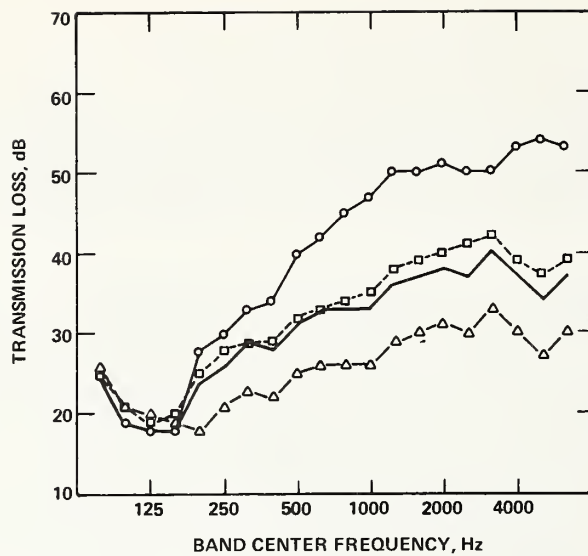
Figure 40. Comparison of measured sound transmission loss vs frequency data for a 6 x 5 ft picture window, glazed single strength, in a wood siding wall with that predicted from the transmission losses and areas of the wall and window (window area = 25.6 sq ft, wall plus window area = 126 sq ft).

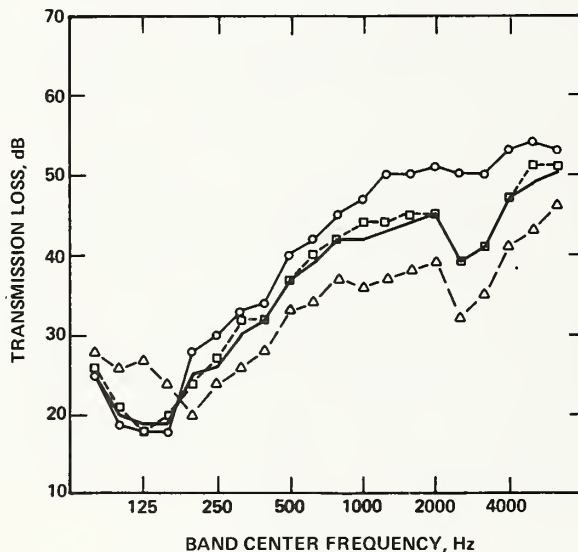
Figure 41. Comparison of measured sound transmission loss vs frequency data for a 6 x 5 ft picture window, glazed 1 in. insulating glass, in a wood siding wall with that predicted from the transmission losses and areas of the wall and window (window area = 25.6 sq ft, wall plus window area = 126 sq ft).

Symbol	Test No.	Specimen	STC
○	W-54-71	wall alone	39
△	W-10-71	window alone	34
□	W-58-71	combination, measured	38
---		combination, calculated	38

Complete test data for the four combinations of the 6 x 5 ft picture window in two walls are shown in Figure 40 to 43. For each combination of wall and window, the measured transmission loss data curve for each component is shown on the charts. Also, on each chart is shown the calculated transmission loss of the combination, this calculation being made using equation (4) with only two areas, that of the wall and that of the window, being used.

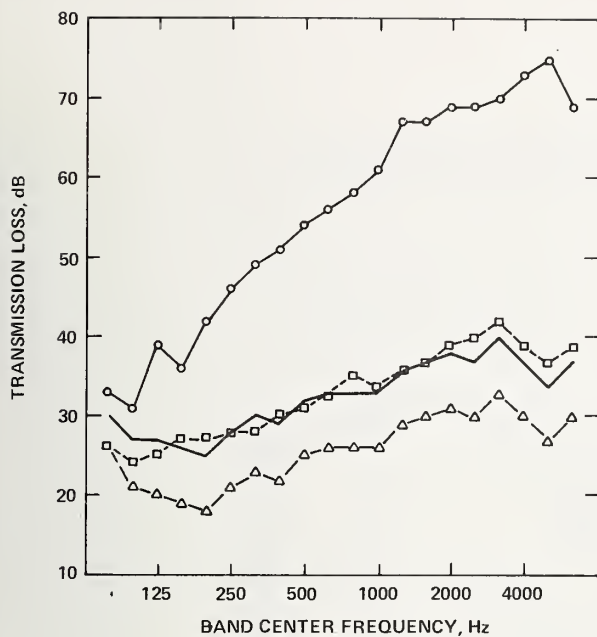
Symbol	Test No.	Specimen	STC
○	W-44-71	wall alone	56
△	W-8-71	window alone	28
□	W-49-71	combination, measured	35
—	---	combination, calculated	35

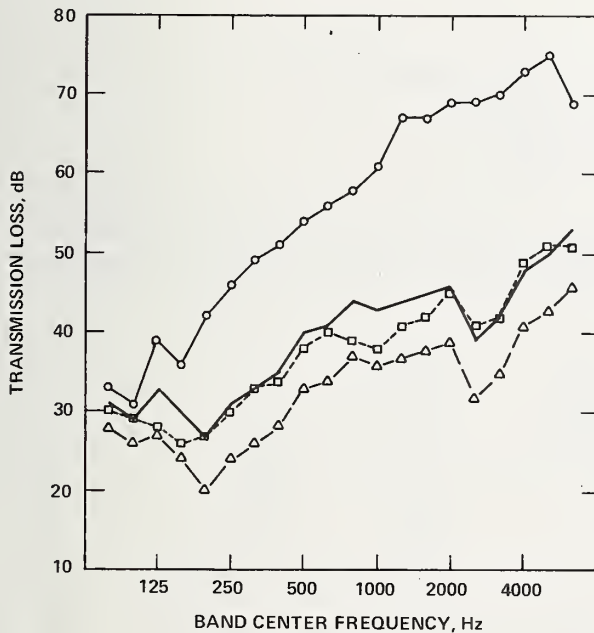
Symbol	Test No.	Specimen	STC
○	W-44-71	wall alone	56
△	W-10-71	window alone	34
□	W-48-71	combination, measured	39
—	---	combination, calculated	41

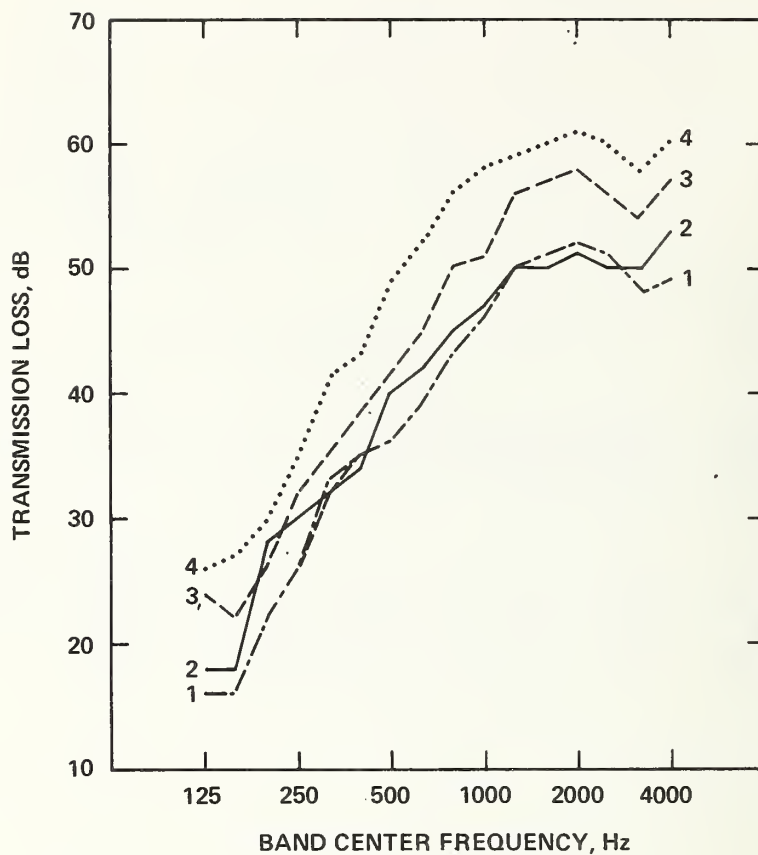
Figure 44. Sound transmission loss vs frequency data for wood-siding, wood-stud, exterior walls. The data are from the present investigation and correspond to walls with or without resilient channels and with or without cavity insulation.

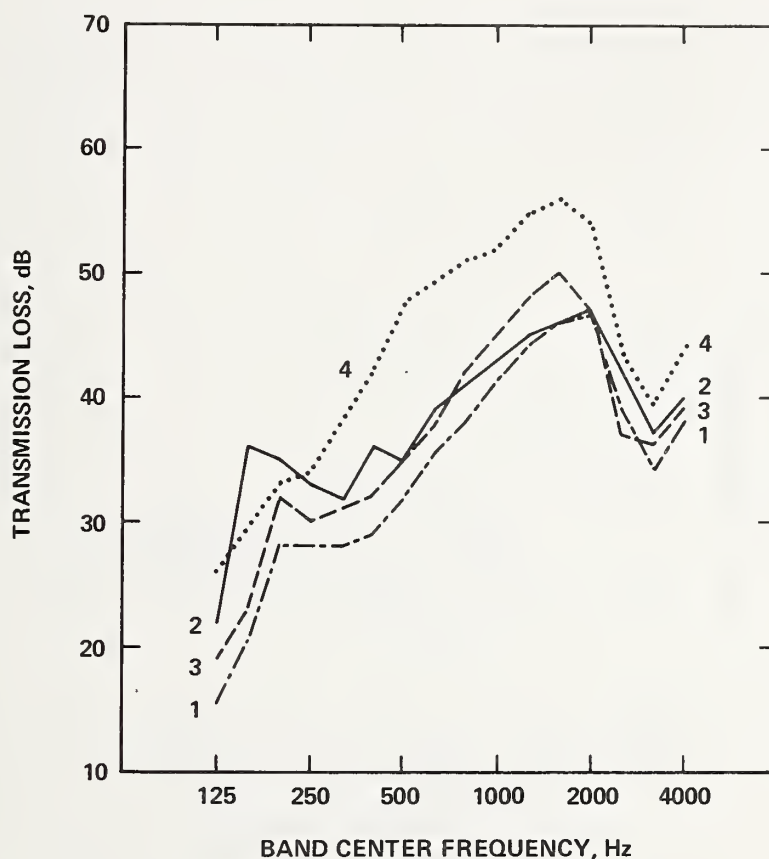
Figure 45. Sound transmission loss vs frequency data for plasterboard interior walls. The data are from Northwood [61] and correspond to walls with wood or metal studs and with or without cavity insulation.
